DETAILS OF THE ACCIDENT PROGRESSION IN 1F1 EMUG 2019

BRAUN, Matthias

Switzerland, 3rd -5th April 2019

MELCOR 1.8.6 Model for 1F1

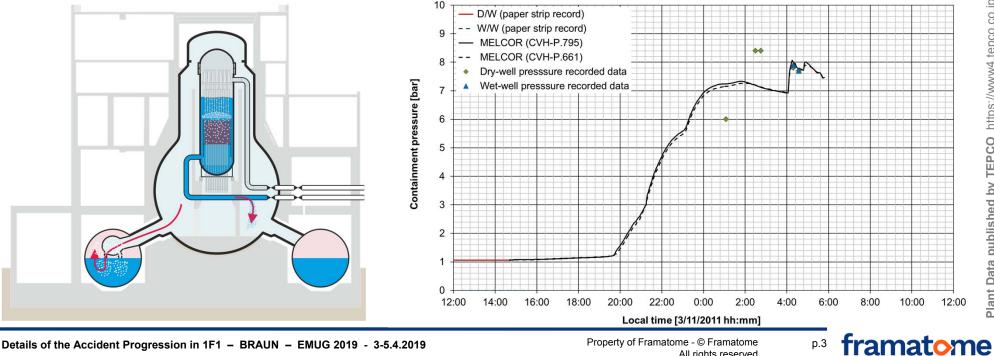
RCS Leakage before RPV Failure? (I of II)

Containment pressure 6 bar-abs at 12th March 01:00

- Likely that RPV failure occurs afterward
- A discharge only via open SRV into the W/W would require > 1500 kg H2 (100% core oxidation) to fill W/W and D/W
- A steam leak in the D/W compresses N2 + H2 into the W/W requiring ~ 500-800 kg H2

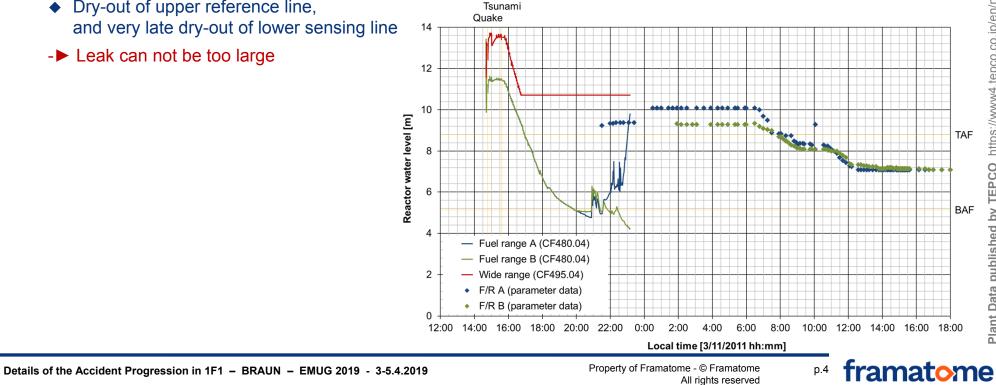
RCS Leakage before RPV Failure? (II of II)

Malfunctioning of RPV water level measurement

- Containment heat-up via insulated RCS unlikely to be sufficient to cause this malfunctioning
- RCS leakage before 11th March 21:30
- Dry-out of upper reference line, and very late dry-out of lower sensing line
- Leak can not be too large

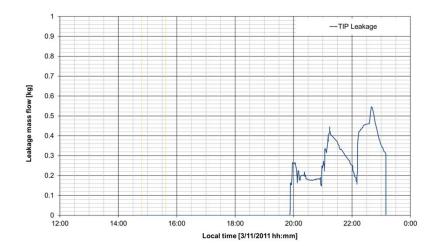
Failure of In-core Dry Tubes (II of II)

TIP dry tube failure?

- Dry tubes fail in ring when bypass fluid temperature > 1400°C
- Steam leakage
- Leakage of failed tubes: 10% of free area (bounding high assumption)
- Pipe length ~20 m, squeezed over first 20 cm, DHYD = 0.001

-> Highly likely that leakage occurs, but flow is expected to be too small to cause level measurement malfunctioning

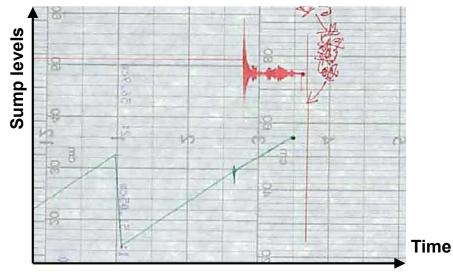
Recirculation Pump Seal Leakage (I of II)

Recirculation pumps seal failure?

- Control rod drive hydraulic system injects ~3 gpm cold water per pump into shaft seal
- Most enter RCS, some leaks to the outside
- Leakage low / high alarm < 0.25 / > 0.9 gpm per pump
- 1F1 equipment sump level rise -> 0.71 gpm => 0.04 kg/s per pump

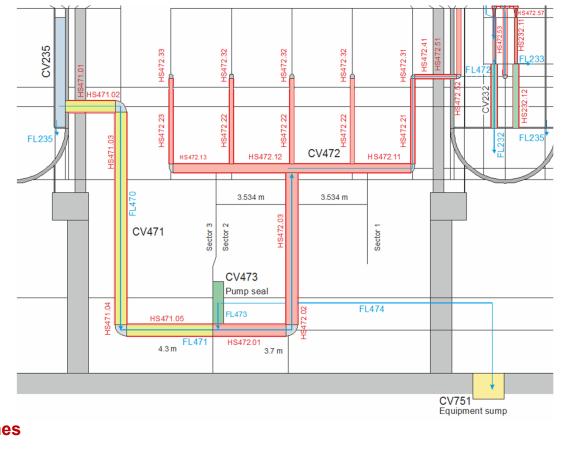
Recirculation Pump Seal Leakage (II of II)

In SBO condition

- Pump seals designed for 160°F ~71°C
- With loss of AC power pump seal cooling stops, possibility causing thermal damage of seals
- In SBO / overheating tests, no significant leakages were observed (NUREG/CR-4821)
- Theoretical max. leakage 100 gpm / 6 kg/s
- Observed operational BWR seal leakages (NUREG-1401) mostly < 10 gpm / 0.6 kg/s
- Steam leakage would be saturated
 - Can not cause a dry-out of the RPV liquid level measurement
- Increase of pump seal leakage in 1F1 appears currently unlikely, but not finally resolved, but it cant cause dry-out of level measurement lines

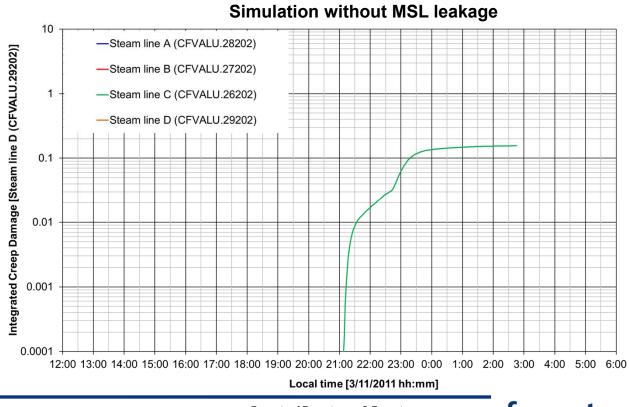
Creep Rupture of Main Steam Pipe (II of II)

At ~ 700°C only limited creep damage

- ♦ ~1% creep damage up to 21:30
- unlikely that pipe failed that early

If main steam pipe failed early on, then likely not by rupturing but at measurement penetrations (compare LHF4, OLHF4) resulting in small leakage

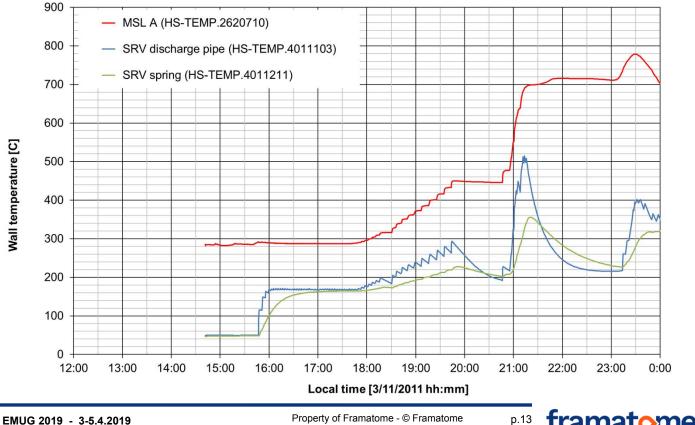
Failure of Safety Relief Valves (II of V)

Simulation temperatures

- SRV body shortly above 500°C
- SRV mechanics cooler ~200°C up to 20:00

Why so "low" temperatures

- Non-insulated - heat loss to PCV
- No continuous flow from RPV - superheated core gas can cool in steam separator & dryer

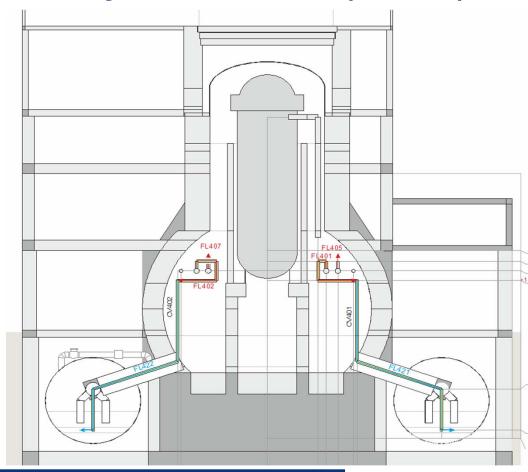
Failure of Safety Relief Valves (IV of V)

SRV stuck-open?

- In simulation, SRV body > 450°C for < 15 min
- Design exceeding, but probably able to stand heat load
- Stuck-open failure would not lead to a heat-up of the PCV atmosphere
- Inconsistent to high containment pressure
- Appears unlikely that SRV failed in open position

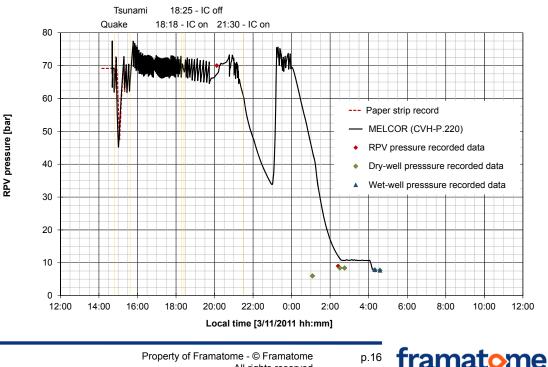
Failure of Safety Relief Valves (V of V)

Shift of actuation pressure?

- Relief function open 72.7 barg / close 69.7 barg relative to environment
- Safety function open 76.4 barg / close 68.8 barg relative to containment (PCV) atmosphere
- Pressure measurement at 20:07 69 barg
- Measured pressure just at the lower edge of the SRV safety opening band (possible but unlikely)
- When pressure is kept via safety valves. PCV pressure causes rise in RPV pressure
- Safety function defined by steel spring
- Heat-up reduces steel Youngs module ~ 4%/100K
- RPV spring temperature 150°C -> 250°C -> SRV set-points ~73 barg and 66 barg
- Likely that heat-up of SRV body caused slight decrease in actuation pressure
