Fukushima Dai-ichi

Short overview of 11 March 2011 accidents and considerations

Marco Sangiorgi - ENEA

**3rd EMUG Meeting – ENEA
Bologna 11-12 April 2011**

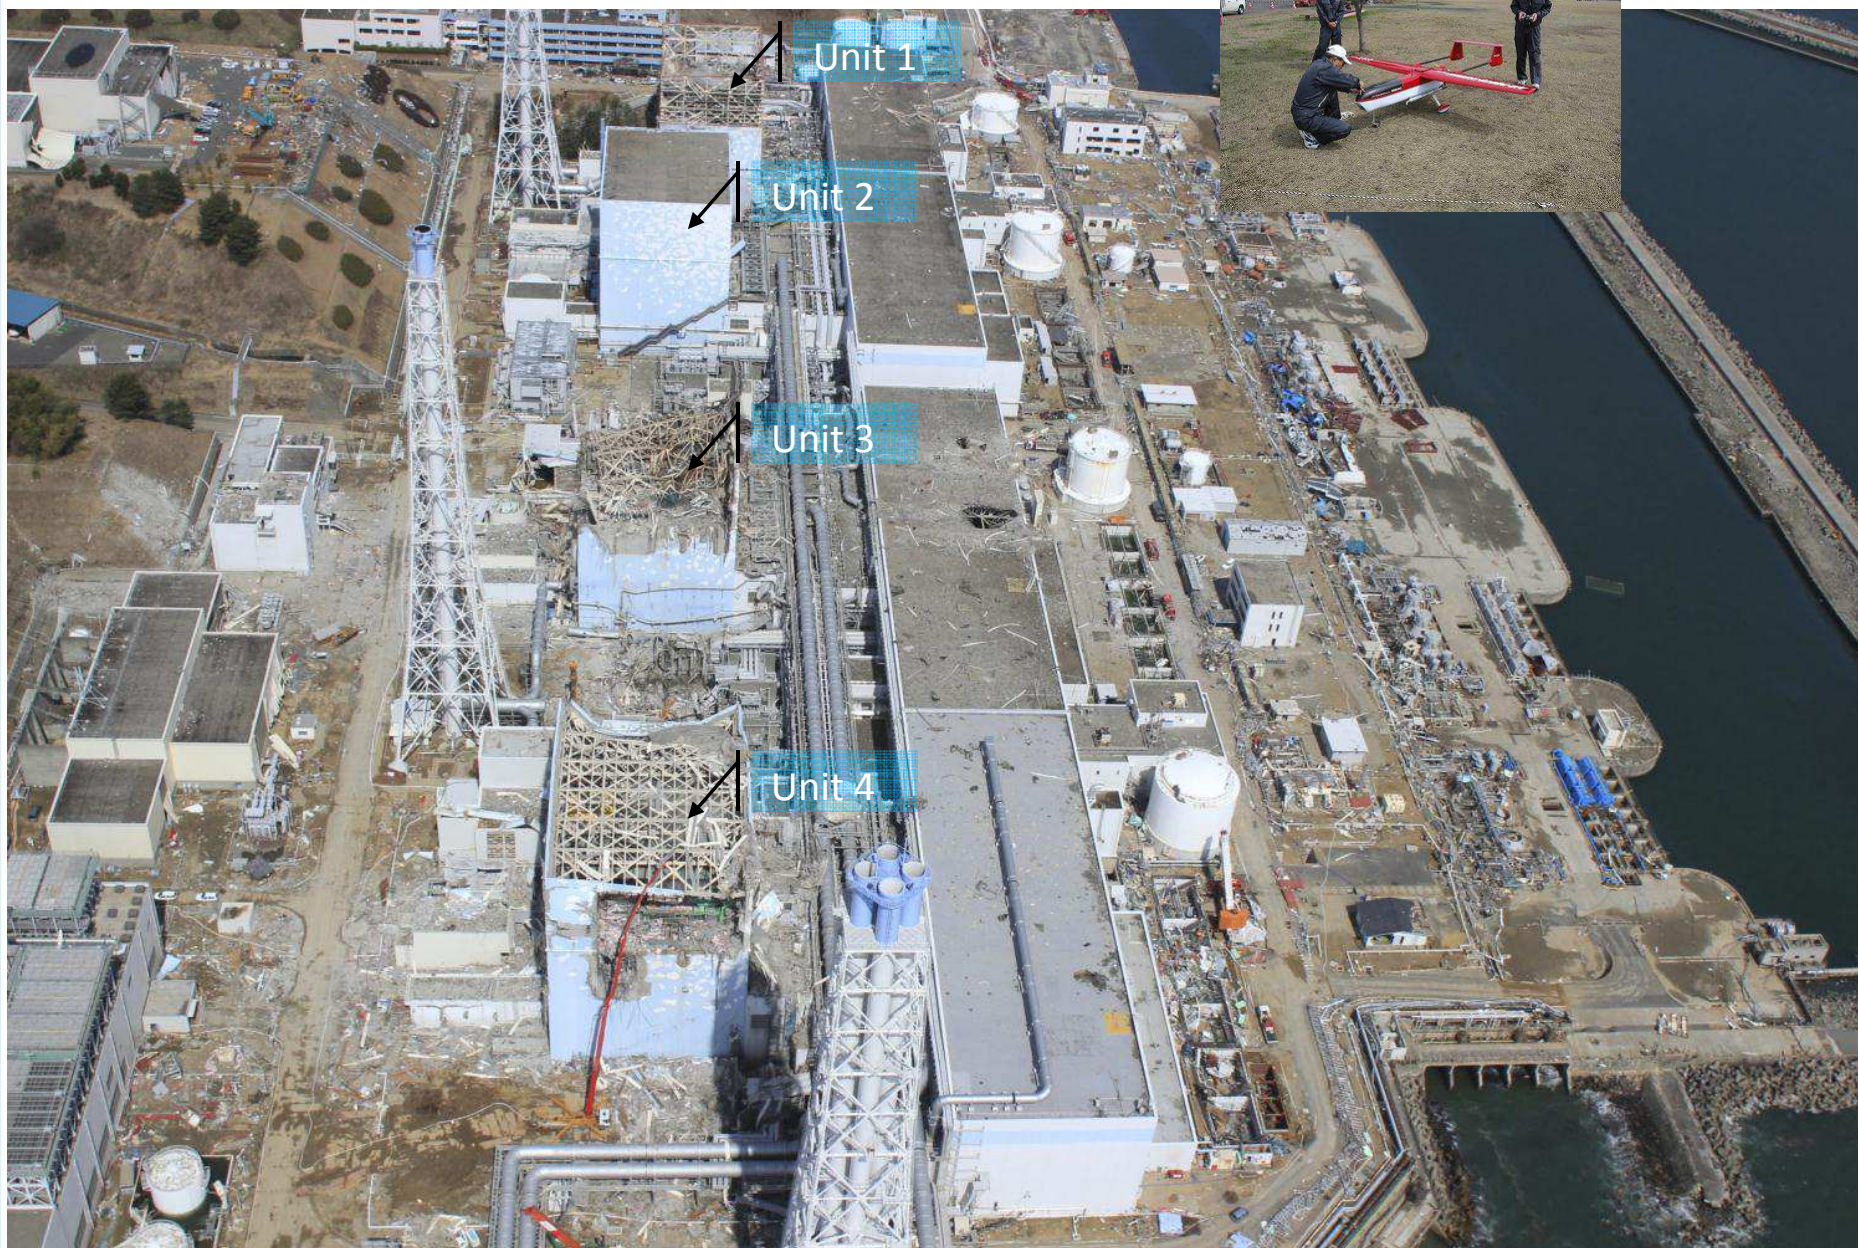
March 24, 2011 aerial photo taken by small unmanned drone

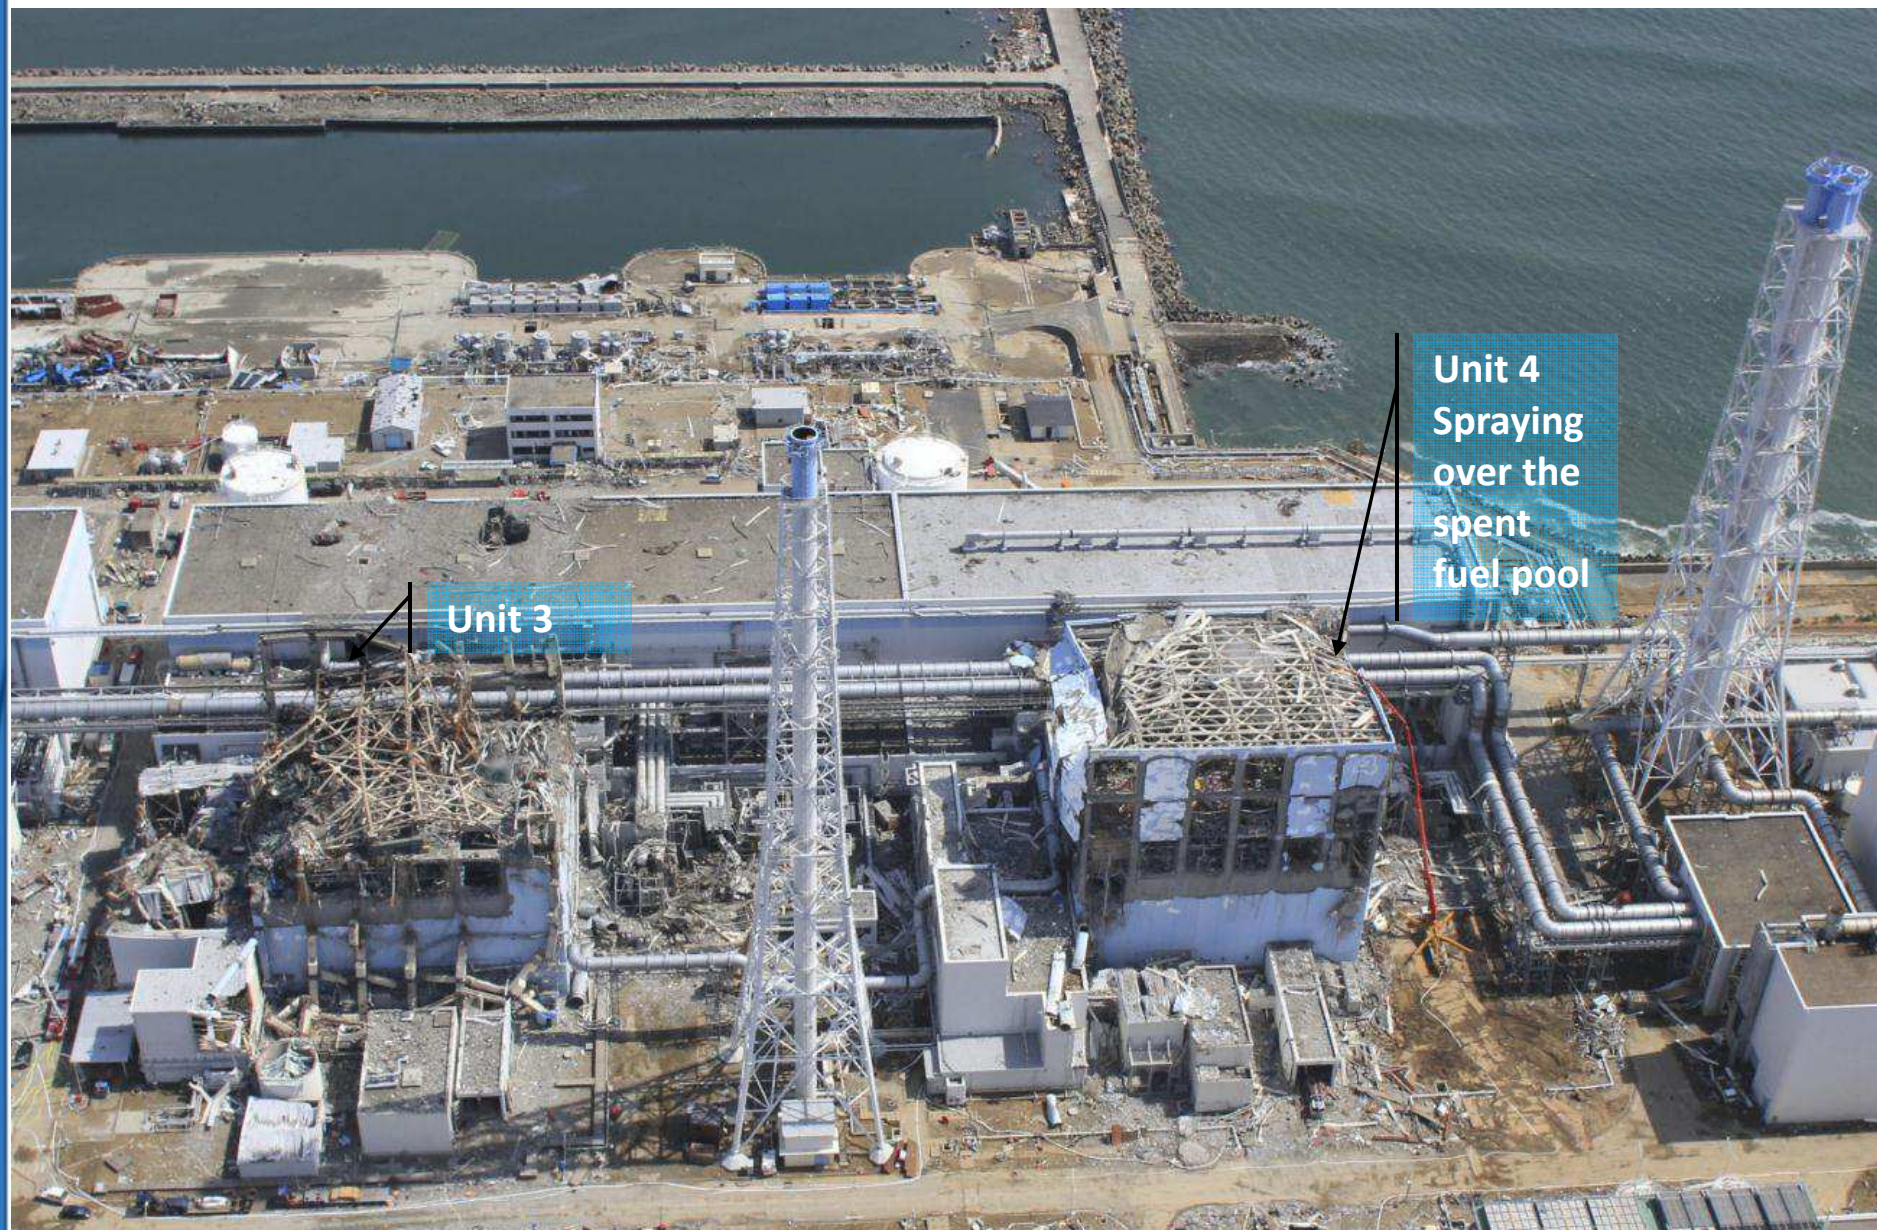
March 24, 2011 aerial photo taken by a small unmanned drone

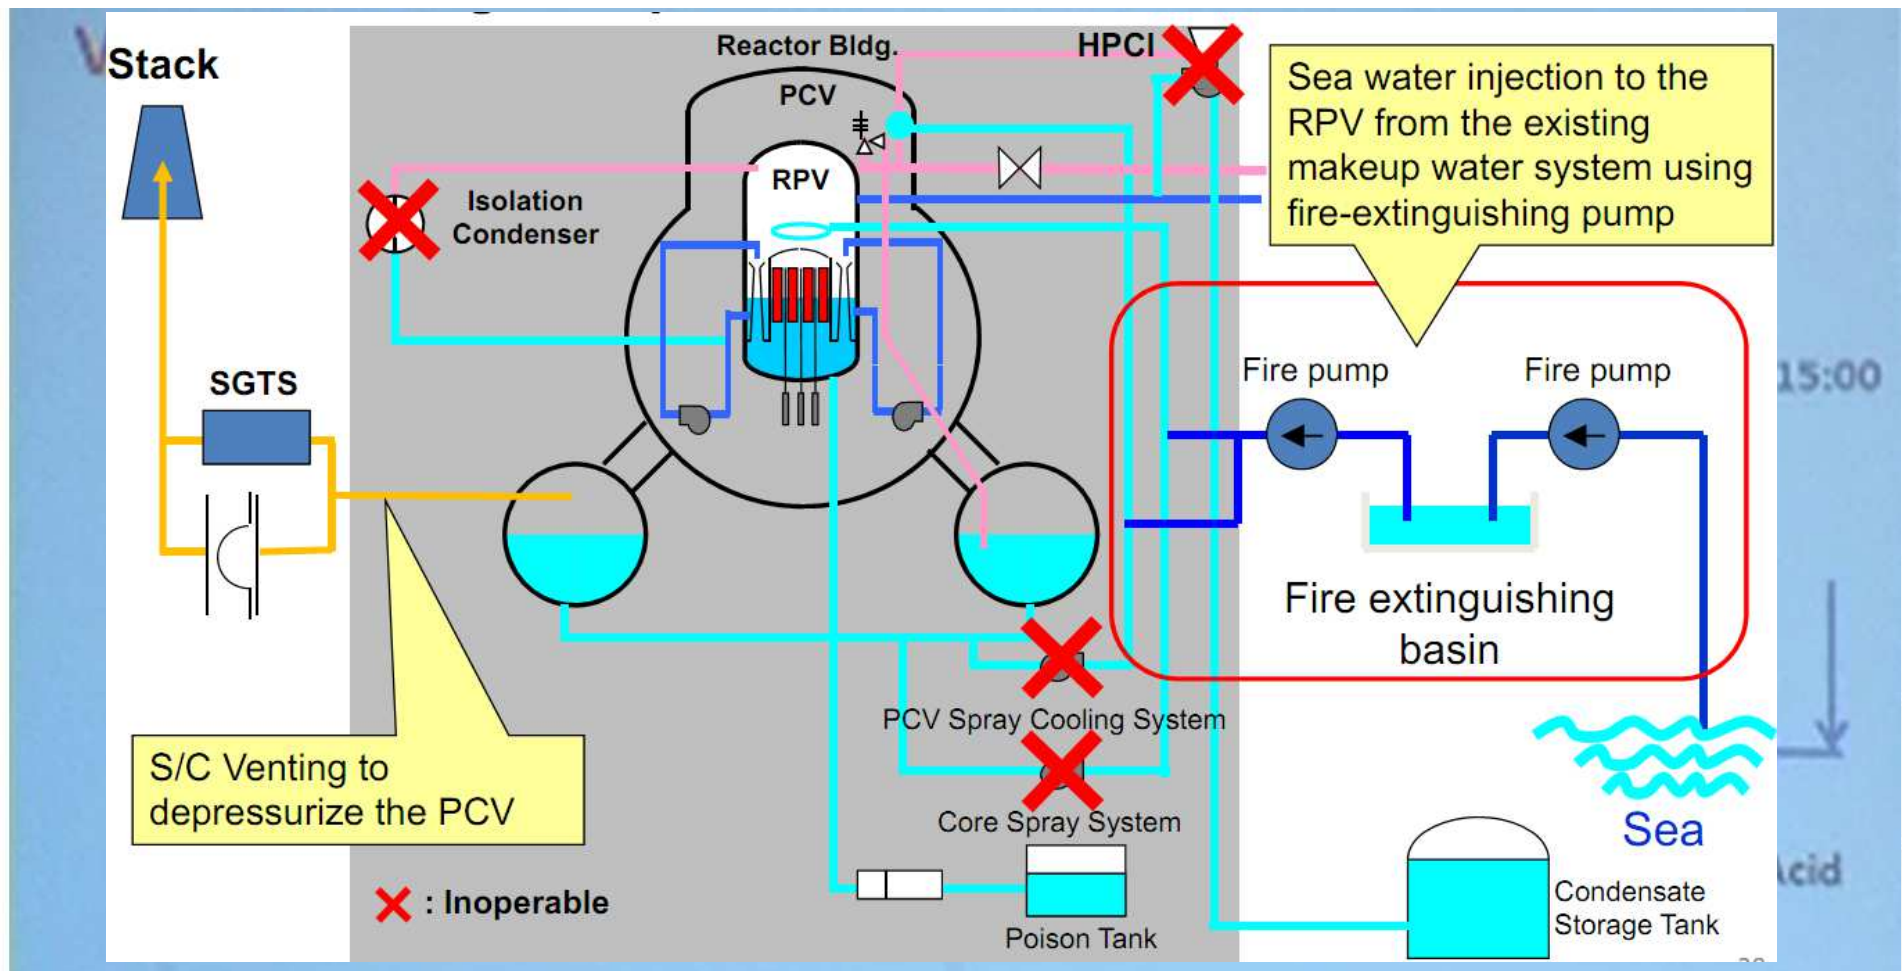
The good news:

thermal control achieved

The bad news:

open loop, venting to the environment
