DETAILS OF THE ACCIDENT PROGRESSION IN 1F1 EMUG 2019

BRAUN, Matthias

Switzerland, 3rd -5th April 2019

MELCOR 1.8.6 Model for 1F1

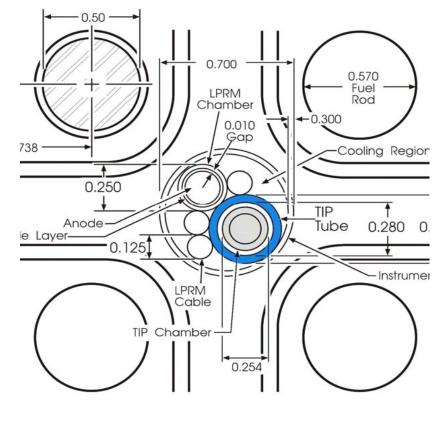
Failure of In-core Dry Tubes (I of II)

TIP dry tube failure?

- Dry tubes open to containment, reach from below into core regions
- Free cross section of 22 lances ~9 cm²
- Highly likely that these dry-tubes get damaged by core overheating
- Uncertain what real leakage cross section is

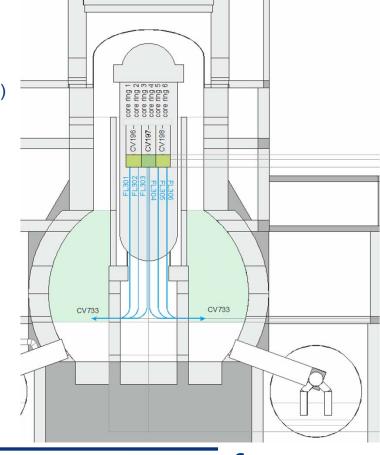
Failure of In-core Dry Tubes (II of II)

TIP dry tube failure?

- Dry tubes fail in ring when bypass fluid temperature > 1400°C
- Steam leakage
- Leakage of failed tubes: 10% of free area (bounding high assumption)
- Pipe length ~20 m, squeezed over first 20 cm, DHYD = 0.001

-> Highly likely that leakage occurs, but flow is expected to be too small to cause level measurement malfunctioning

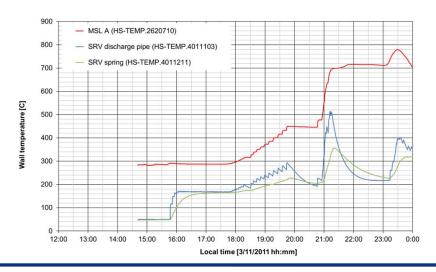
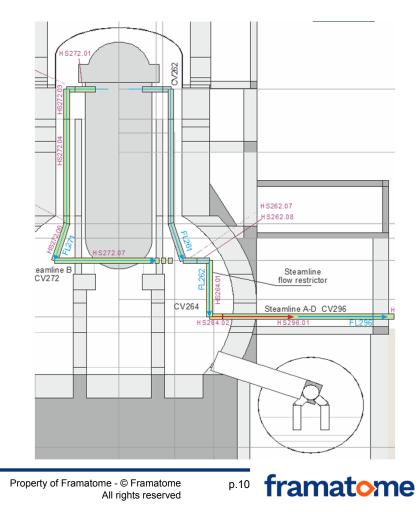
Creep Rupture of Main Steam Pipe (I of II)

Main steam lines

- Transports steam from RPV to turbine
- 18 inch schedule 80 piping, thermally insulated
- Closed off by main steam isolation valves
- Reach ~700°C up to 21:30 on the March 11th
- No continuous flow from RPV
 - -> superheated core gas can cool in steam separator & dryer

At ~ 700°C only limited creep damage

- ♦ ~1% creep damage up to 21:30
- unlikely that pipe failed that early

If main steam pipe failed early on, then likely not by rupturing but at measurement penetrations (compare LHF4, OLHF4) resulting in small leakage

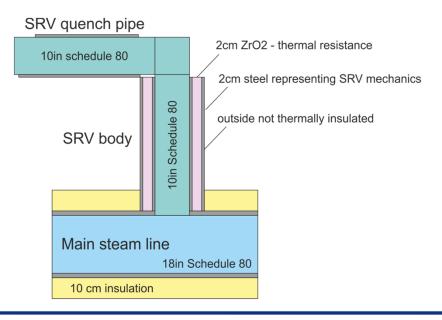
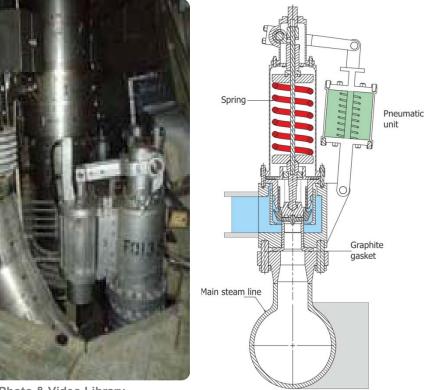
Failure of Safety Relief Valves (I of V)

Safety relief valves

- Relief function by pneumatic cylinder
- Safety function by spring
- Flanged with graphite gasket (design temperature 450°C)
- Dump steam into suppression pool via 10 inch pipes

SRV gasket failure?

- In simulation, SRV temperature (450°C) exceeded for < 15 min
- Exceeding the design does not mean failure
- > 700°C graphite gets oxidized (slowly) by steam
- Highly unlikely that SRV gasket started leaking

- In simulation, SRV body > 450°C for < 15 min
- Design exceeding, but probably able to stand heat load
- Stuck-open failure would not lead to a heat-up of the PCV atmosphere
- Inconsistent to high containment pressure
- Appears unlikely that SRV failed in open position
