Bernd Jäckel :: Paul Scherrer Institut

# Conversion of SFP input deck from MELCOR 1.8.6 to 2.1 and back

EMUG, 07.04.2016

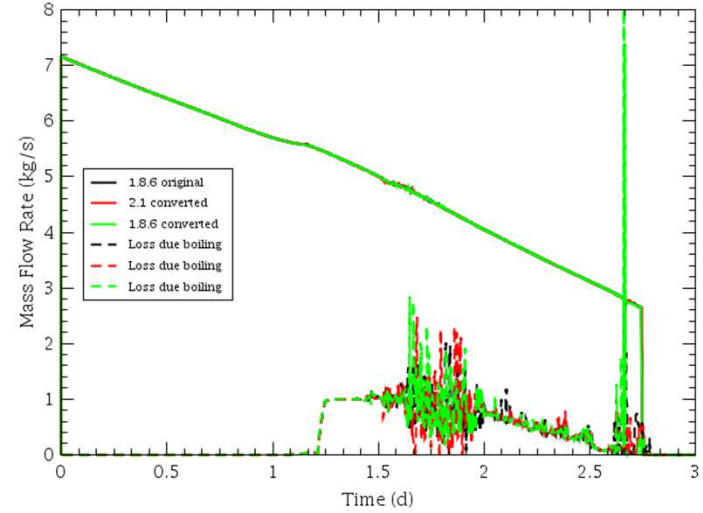
**Identical results until beginning of fuel uncover.**  
**numerical instable behavior of the code leads to slightly different calculation.**

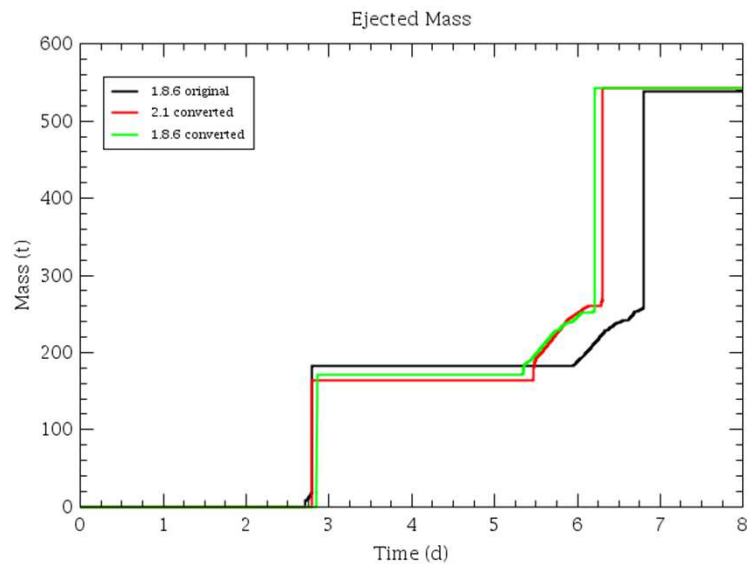
The ejected mass is almost identical except of the timing.

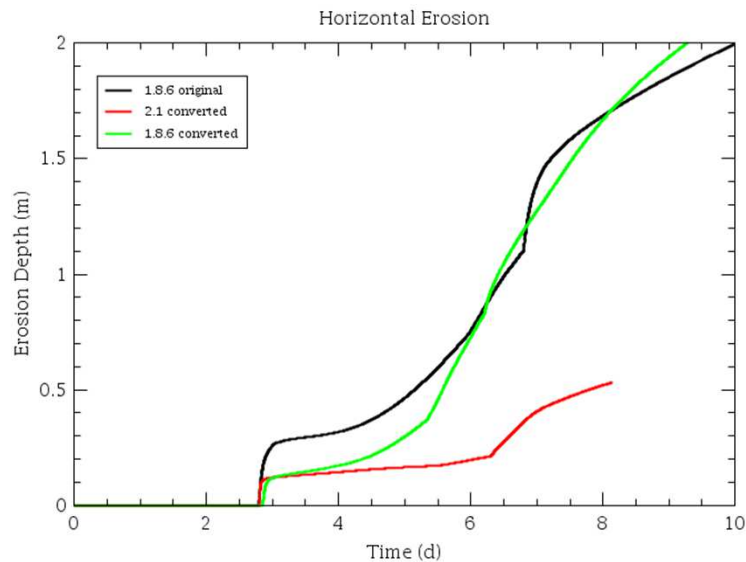
**Also the horizontal concrete ablation is strongly different between MELCOR 1.8.6 and MELCOR 2.1.**
